LOW RF LOSS METAL-CERAMIC BONDS

NORTHROP DEFENSE SYSTEMS DEPARTMENT
ELECTRON TUBE SECTION
DES PLAINES, ILLINOIS 60018

NOVEMBER 1976

FINAL TECHNICAL REPORT NOVEMBER 1976 - DECEMBER 1976

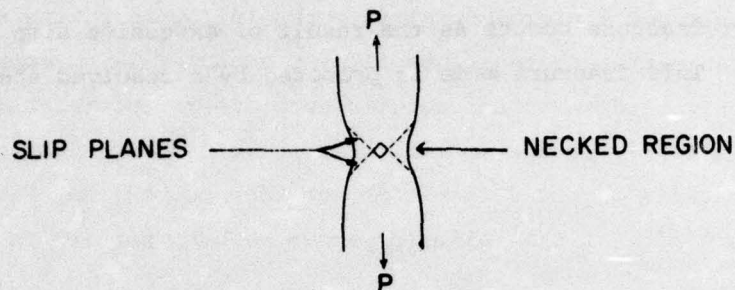
Figure 2. Ductile Fracture Observed in Polycrystalline Metals Subjected to Uniaxial Tension.

Tensile fracture of moderately ductile polycrystalline metals such as copper eventually produces a necked region as shown in figure 2. Fracture begins at the center of the specimen and then extends by shear along the dashed lines (figure 2). A shear fracture occurs as the result of excessive slip on the active slip planes. This fracture mode is promoted by a resolved shear stress.²

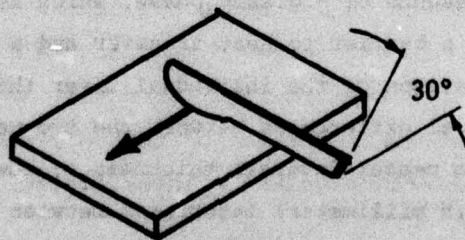
Figure 3. Technique Employed for Peel Test.

A technique for evaluating the general adhesion was devised. The test involves scraping the sputtered films with a scalpel blade as depicted in figure 3. Examination under a microscope led to the following rating system:

- A. Designates an extremely tenacious film; the copper layer snow plows and will not peel down to the ceramic even after repeated shaving.
- B. Designates a fairly strong adhered film; some discontinuous patches of peeled metallizing in a matrix of adherent copper; may require more than one pass of the knife to remove some copper (swiss cheese appearance).
- C. Designates a film of moderate strength; peeling occurs continuously with difficulty and only in the area of the knife slice.
- D. Designates poor film adherence; peels with little effort in the area of the knife contact region.
- E. Designates a film of essentially no adherence; copper peels as a foil with no effort, virtually no knife is needed; lifting can be started and continued with the use of tweezers.

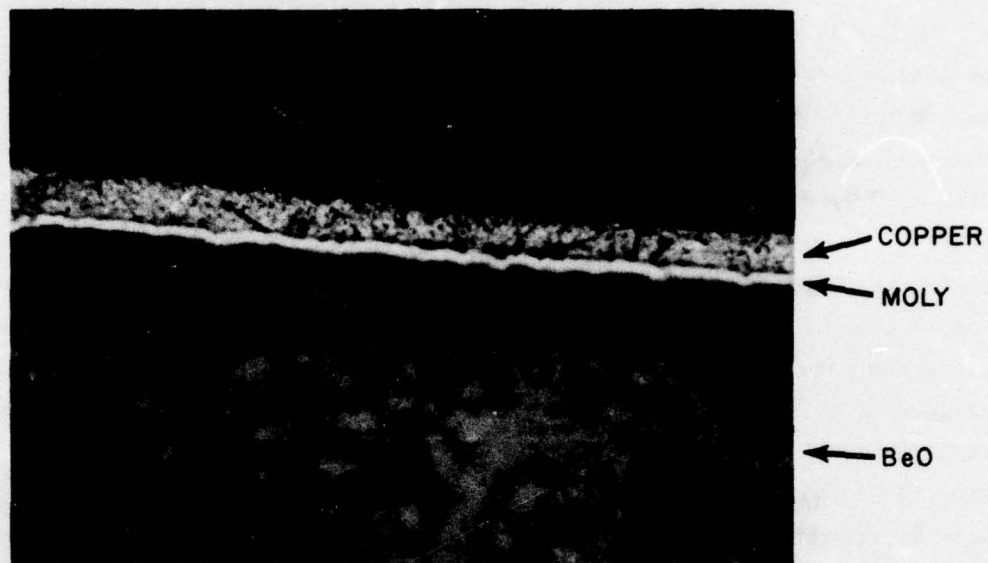
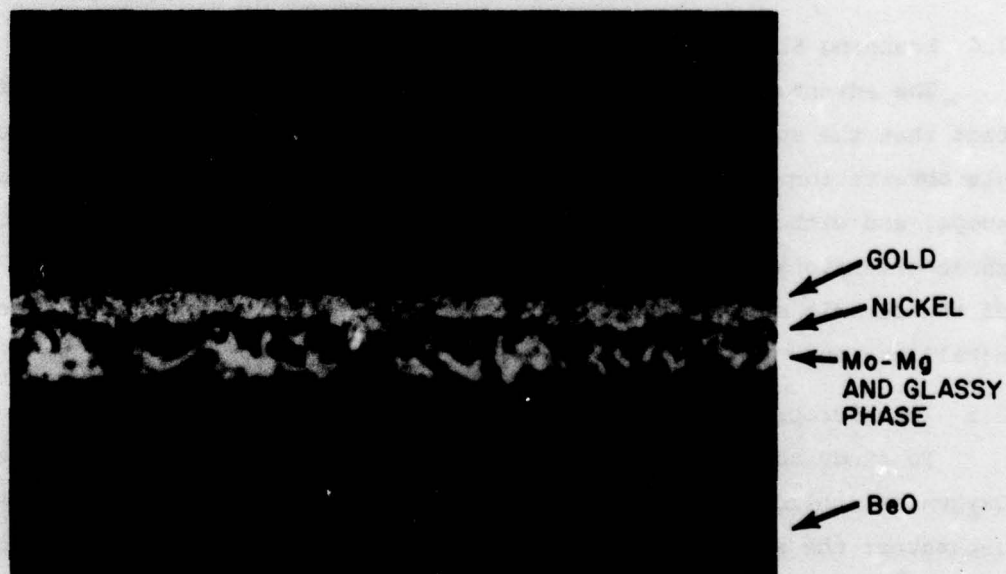
Figure 4. Comparison of Sputter Metallization and Moly-Manganese Metallization.

A. SPUTTER METALLIZING (THIN FILM)X947

B. MOLY-MANGANESE METALLIZING (THICK FILM)X947

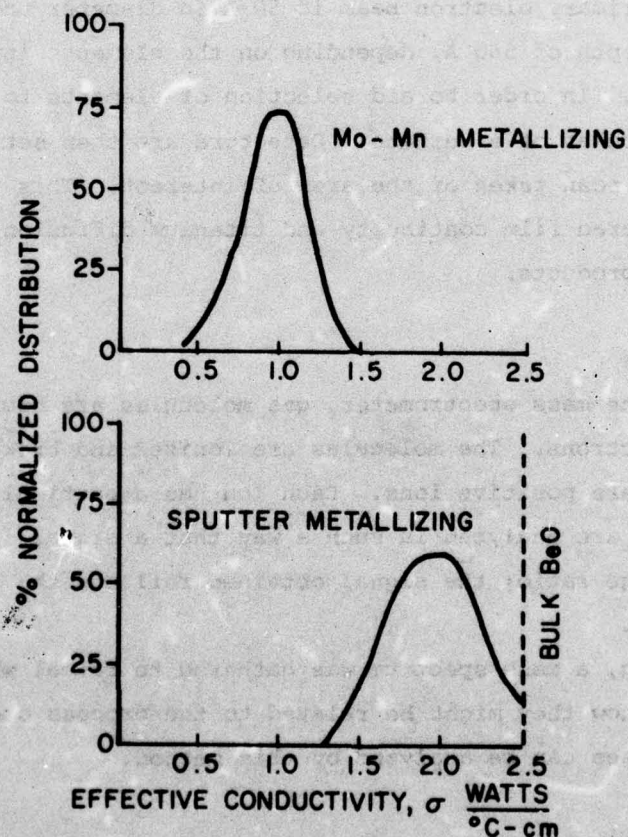
Figure 6. Statistical Thermal Conductivity Comparison.

thermal conductivity for moly-manganese and sputter metallizing is shown in figure 6. It is evident that the sputter metallizing poses less of a thermal barrier than moly-manganese metallizing.

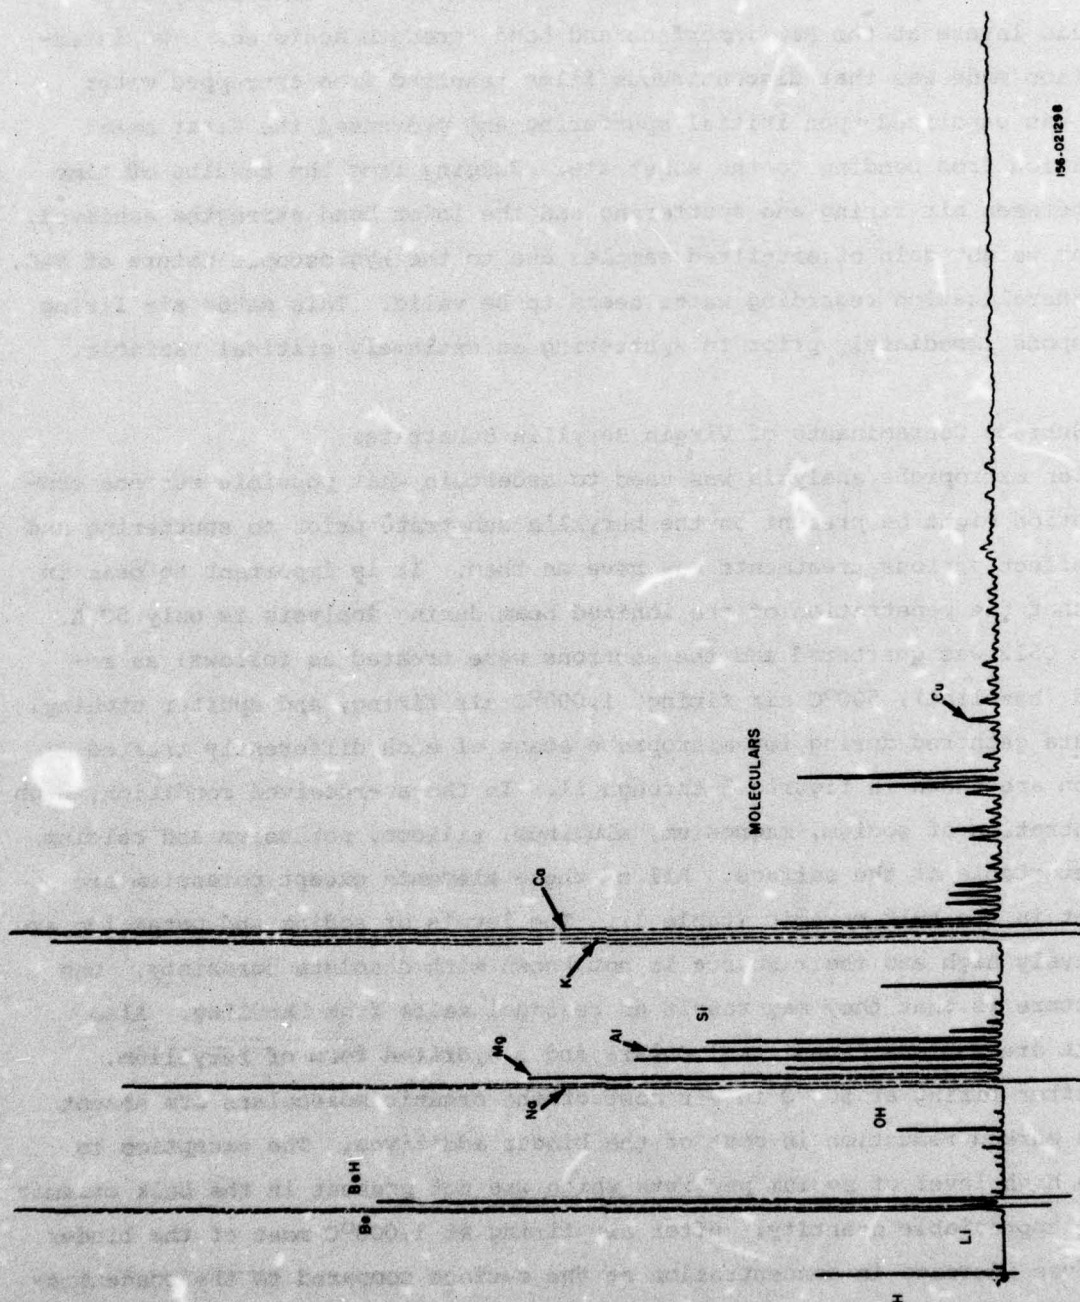
Figure 8. Ion Microprobe Data for Q512 in the As-Received Condition.

Ion microprobe analysis was used to ascertain what possible surface contamination might be present on the beryllia substrate prior to sputtering and what effect various treatments may have on them. It is important to bear in mind that the penetration of the ionized beam during analysis is only 50 Å. Coupon Q512 was quartered and the sections were treated as follows: as received (baseline), 500°C air firing, 1,000°C air firing, and sputter etching. The data gathered during ion microprobe scans of each differently treated section are shown in figures 8 through 11. In the as-received condition, high concentration of sodium, magnesium, aluminum, silicon, potassium and calcium are detectable at the surface. All of these elements except potassium are present in the bulk ceramic (table 1). The levels of sodium and potassium are relatively high and their source is not known with absolute certainty. One conjecture is that they may result as residual salts from handling. Also present are various organic moleculars and a hydrated form of beryllium.

The overall phenomenon occurring at the ceramic surface in terms of surface chemistry is not understood and the ion microprobe results are not definitive. Sodium concentrations are particularly curious since their bulk level is very low compared to other binder additives which appear in lower quantities at the surface. Improper handling prior to analysis could have introduced salts which would appear at the surface. A more detailed review of cleaning treatments shall be conducted as a part of the next phase of this study.

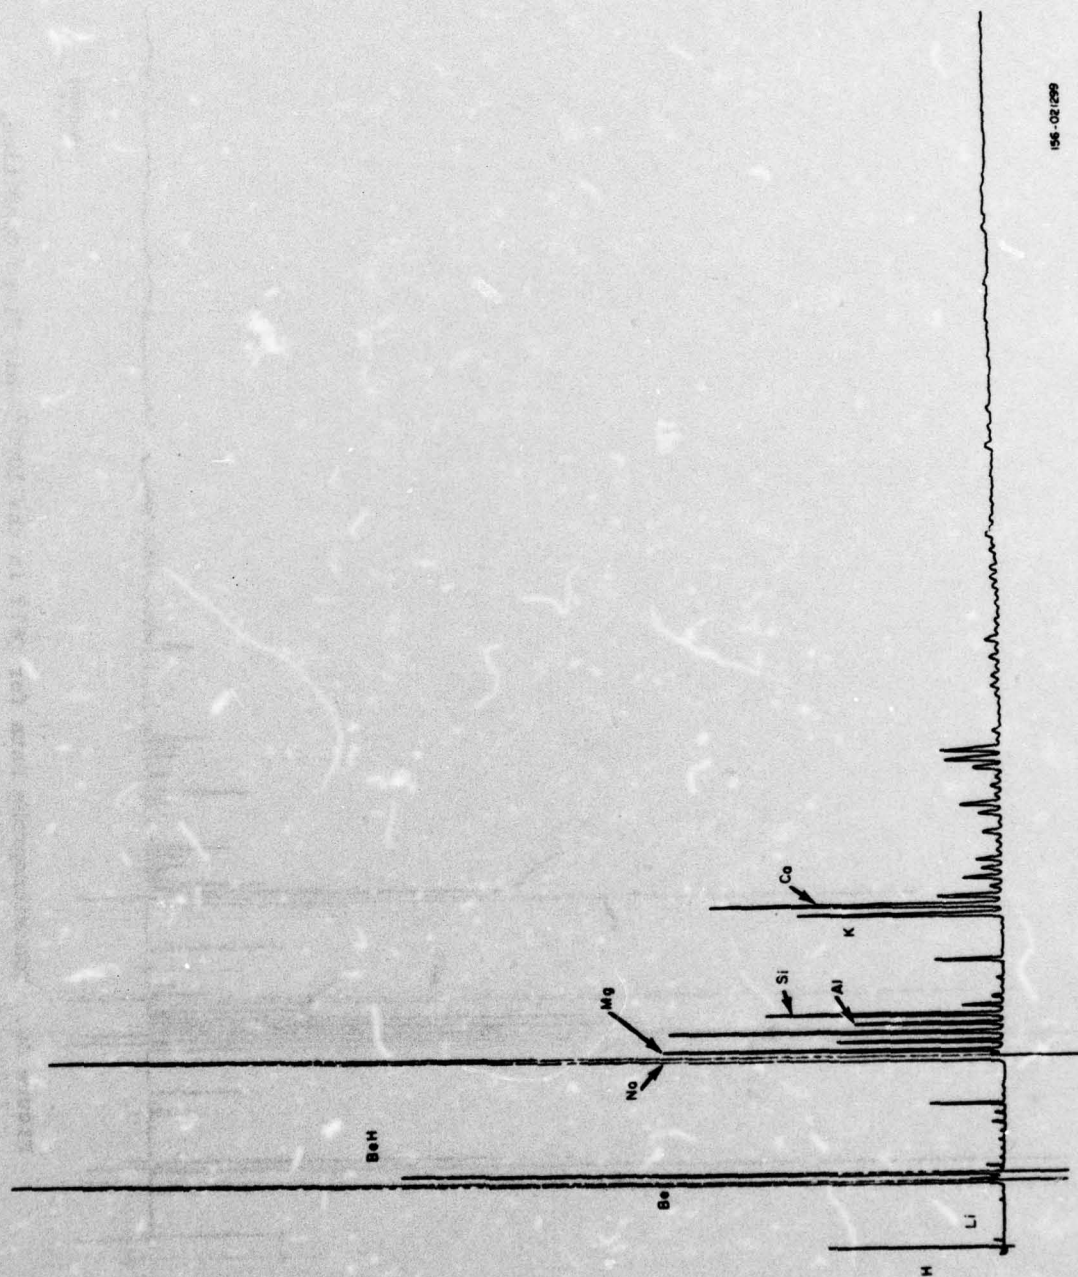
Figure 9. Ion Microprobe Data for Q512 in the 500°C Air Fired Condition.

After firing at 500°C in air most of the organic moleculars are absent with a marked reduction in most of the binder additives. The exception is that a high level of sodium persists which was not present in the bulk ceramic in any appreciable quantity. After air firing at 1,000°C most of the binder additives increase in concentration at the surface compared to the concentration found in samples fired at 500°C. Aluminum remains low, but sodium, sili-

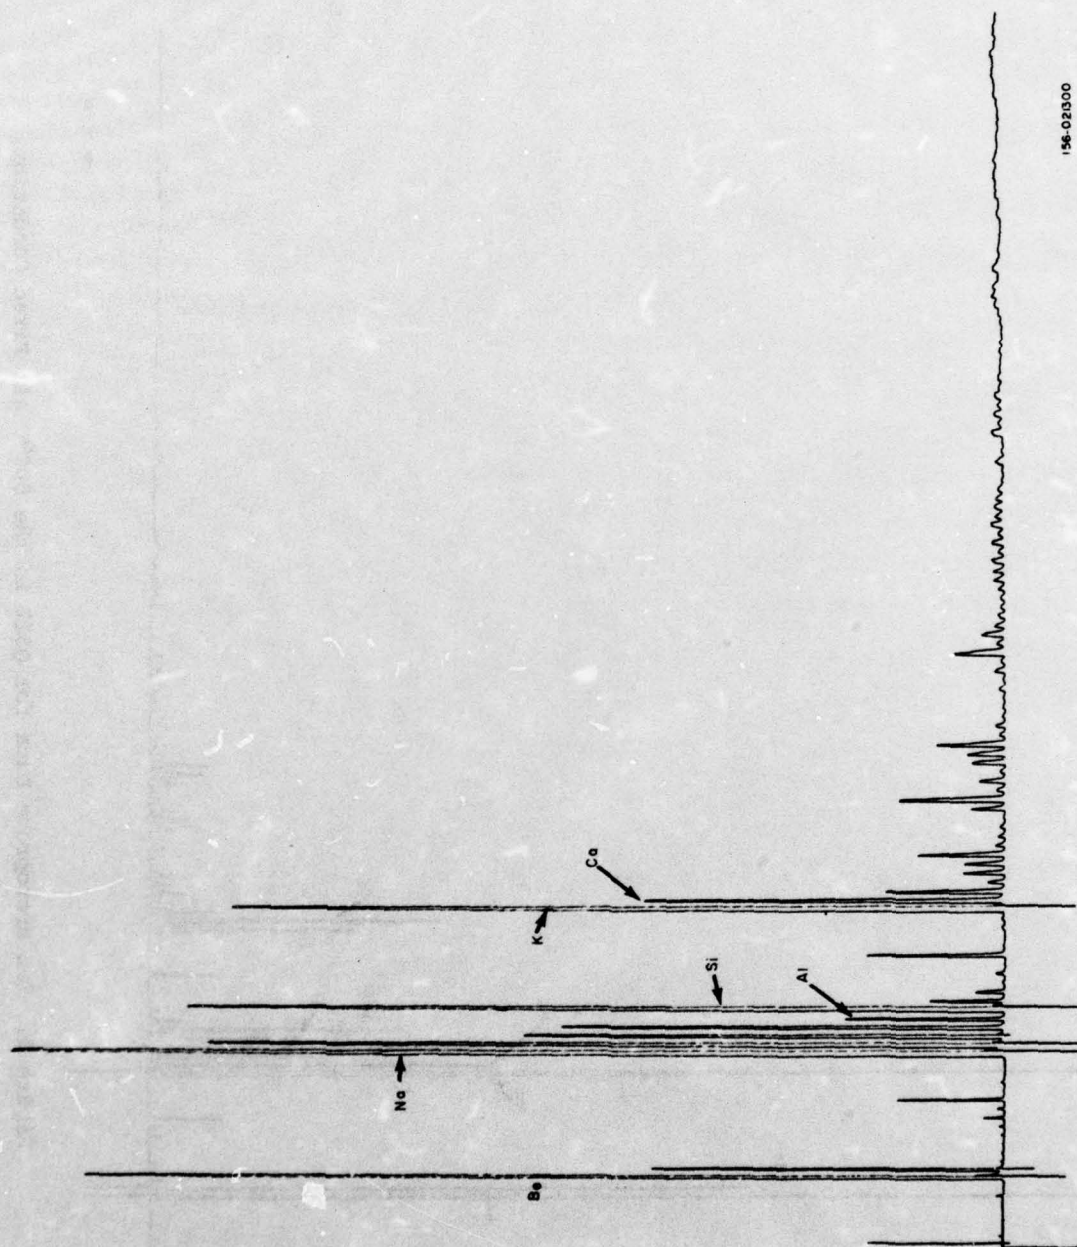
Figure 10. Ion Microprobe Data for Q512 in the 1000°C Air Fired Condition.

con, and magnesium increase to a level higher than that of the as-received state, while potassium and calcium increase only slightly. The increase of all the elements noted is believed to be a result of their migration to the surface at the higher temperature.

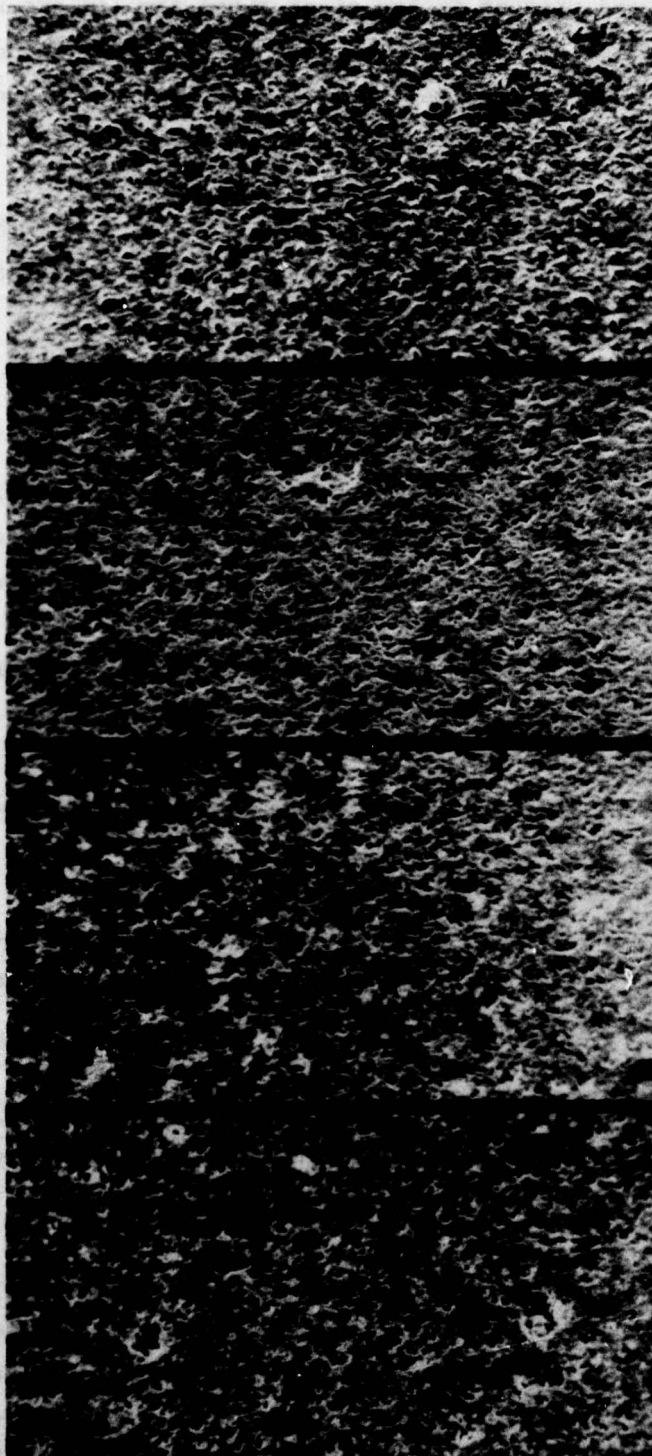
SEM photographs reveal that the as-received, 500°C and 1,000°C air-fired portions of the coupon appear identical. This means that air firing removes only moisture and volatile lapping residuals without altering the surface finish of the substrates. Sputter etching, however, improves the surface

A. AS RECEIVED

B. SPUTTER ETCHED

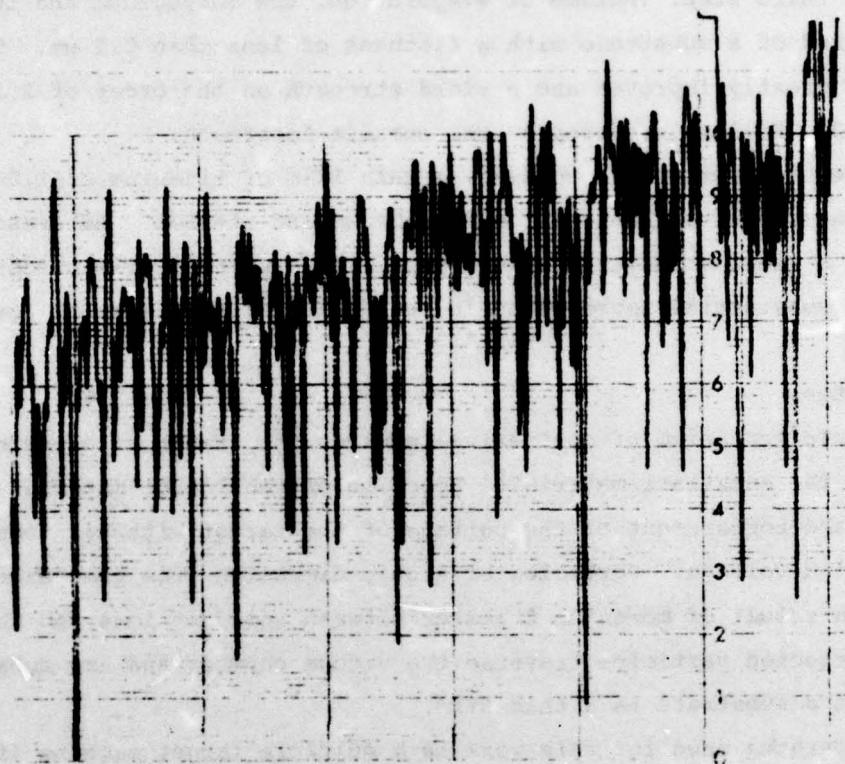
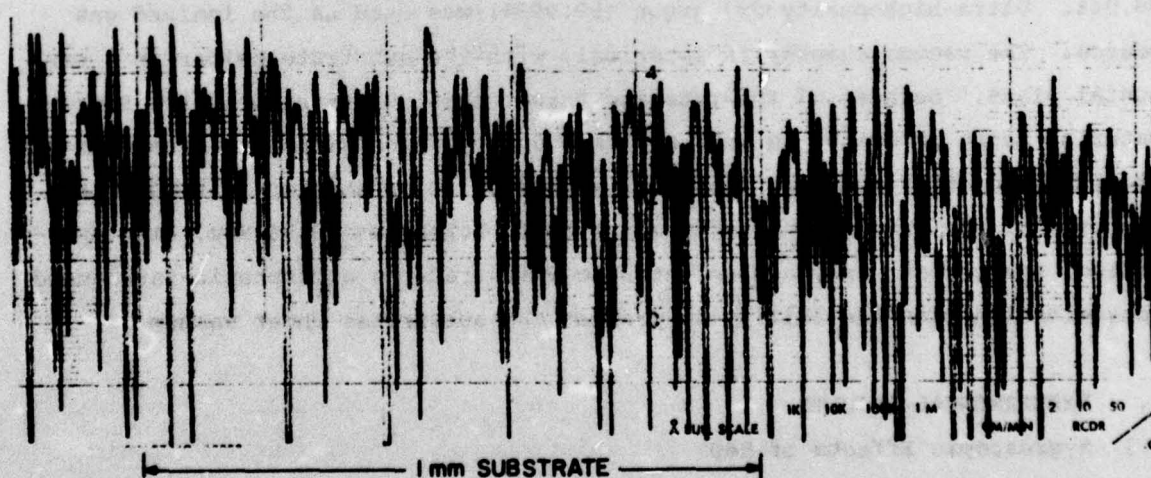
The effects of pre-sputtering treatments upon the beryllia substrates surface roughness were studied with the aid of a scanning electron microscope (SEM). Surface topology for each of the following sample preparations was determined: as received, sputter etched, and 500°C and 1,000°C air firing. Figure 12 depicts the SEM photos for the studied treatments at 240X. For this analysis, one coupon was quartered (Q512) and each quarter used for only one of the above tests. The surface roughness of the coupon as a whole initially was 6 to 8 microinches rms, as measured using a profilometer.

A. AS RECEIVED - 10 MICROINCHES RMS

B. SPUTTER ETCHED - 8.5 MICROINCHES RMS

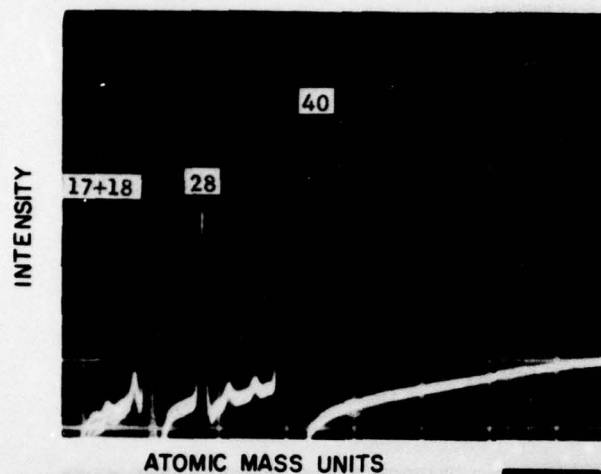
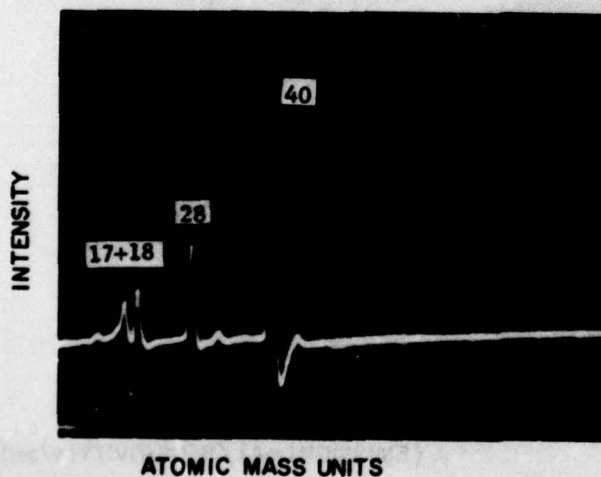
Figure 15. Mass Spectrometer Data During the Sputtering of Q516
(14-Day Delay After Air Firing).

Mass spectrometer data during sputtering for all the fired coupons are similar to those depicted in figure 15, which are for the 14-day delay (Q516). Indications of the presence of water (17 & 18), nitrogen (28), argon (40) and krypton (84) were observed. The krypton is present due to residual amounts remaining in the system after it was used as a calibration element for the mass spectrometer. In the case of the coupon (Q519) which had no air firing prior to sputtering, numerous additional peaks were observed during the initial titanium sputtering (figure 16); after this stage, no additional elements other than the typical water, nitrogen and argon were observed, as indicated by the similarity to the fired coupons' spectra during molybdenum and copper sputtering. The atomic mass units (and their signal strengths) of the contaminants observed during titanium deposition (figure 16A) were:

A. TITANIUM SPUTTERING
(0.8/0.5) *

B. MOLYBDENUM SPUTTERING
(0.8/0.5) *

C. COPPER SPUTTERING
(0.8/0.5) *

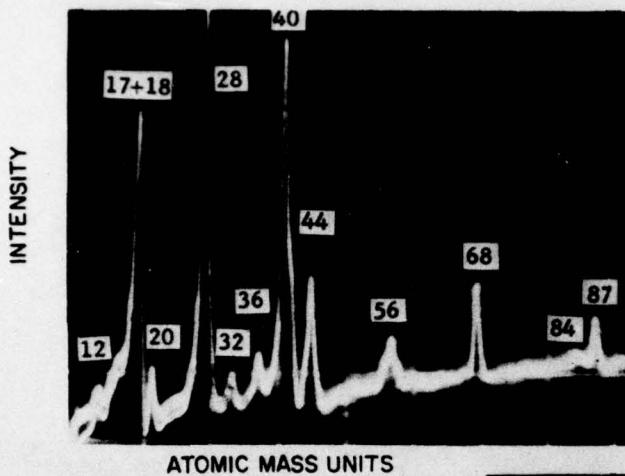
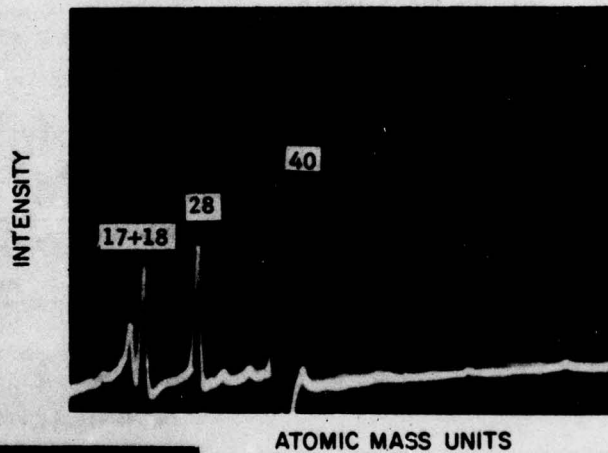
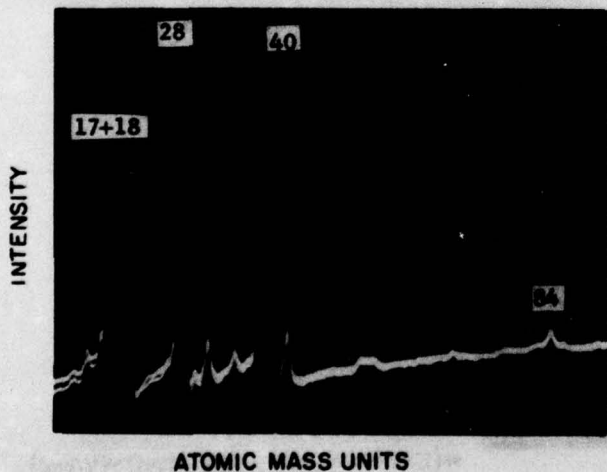
A. TITANIUM SPUTTERING
(0.8 / 0.2) *

B. MOLYBDENUM SPUTTERING
(0.8 / 0.2) *

C. COPPER SPUTTERING
(0.8 / 0.1) *

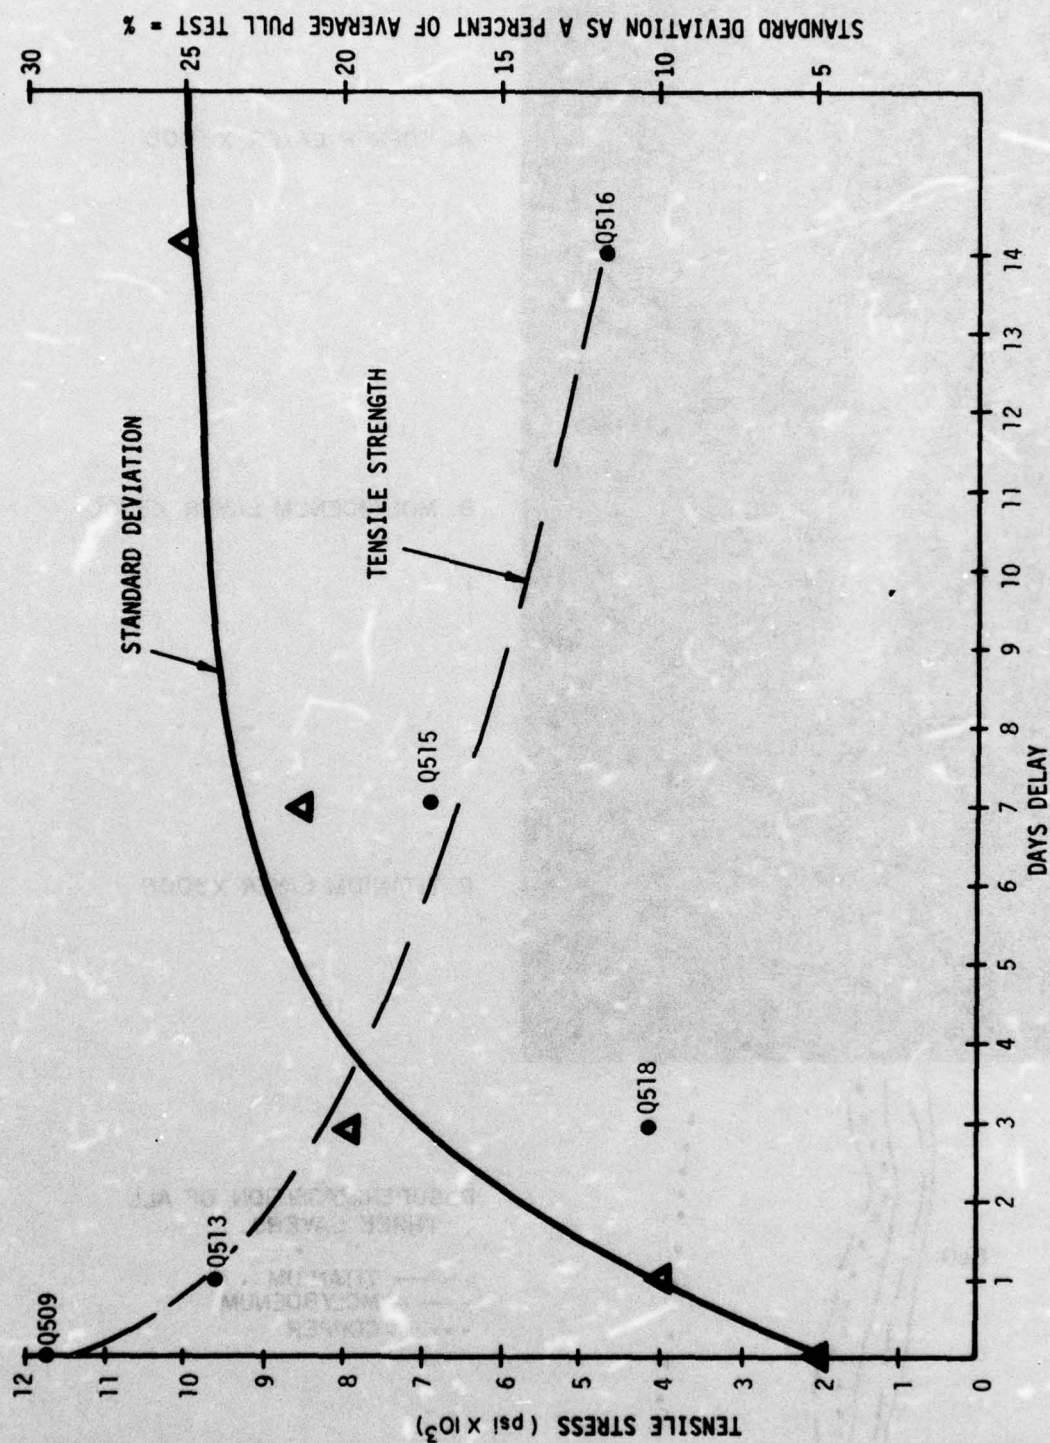
Figure 17. Failure Tensile Stress Versus Days Delay After Air Firing Prior to Sputtering.

The effect of moisture on the bonding of sputtered films on BeO was tested. The average tensile stress results of these tests along with the standard deviation are shown in table 2 for different delays. Figure 17 is a plot of the average failure stress versus time delay; a trend exists that with longer delay time between air firing and sputtering, the tensile strength of the metallized ceramic bond is lower. An exception to the general trend is that with a 3-day delay, the tensile strength is markedly lower than the overall trend. This is an anomaly and an indication of the broad variation introduced by delaying sputtering after air firing and allowing moisture to re-establish on the hygroscopic substrate. Also noteworthy is that the standard deviation as a percentage of the average yield stress increases markedly with delay time. Not only does moisture reduce the bond strength attainable, but the variance in bond strength increases with moisture pickup.

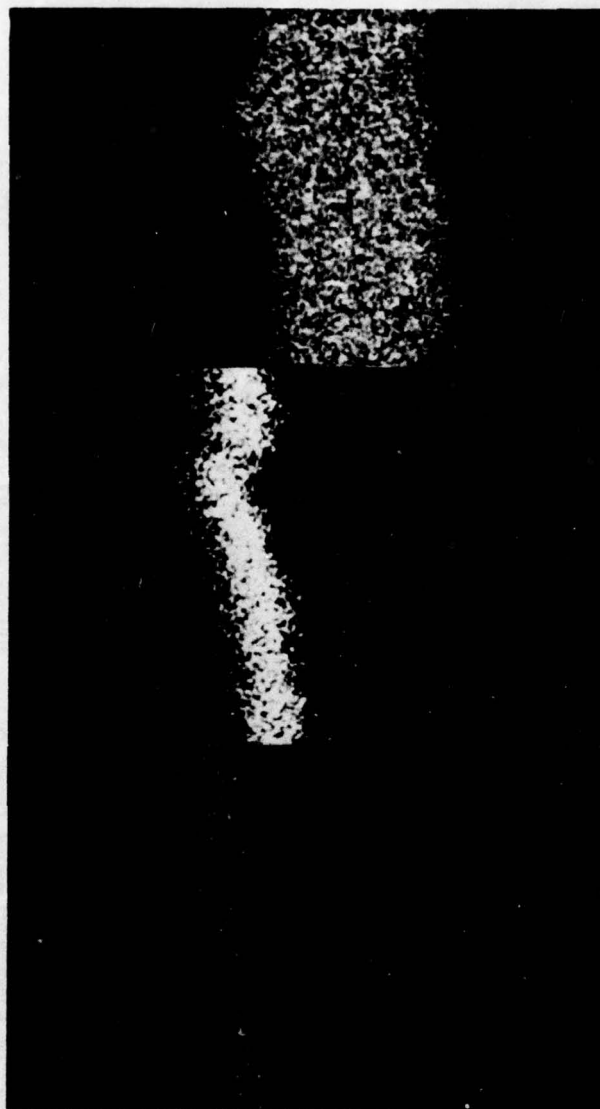
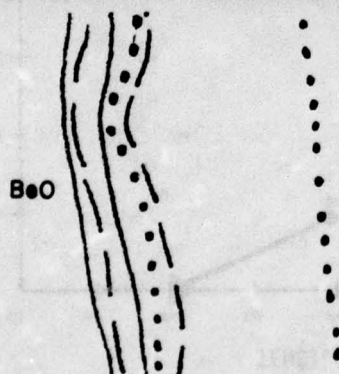
Figure 18. Film Morphology for Q509, Air Fired, No Delay,
Side 1, As Sputtered.

A. COPPER LAYER X3000

B. MOLYBDENUM LAYER X3000

C. TITANIUM LAYER X3000

D. SUPERIMPOSITION OF ALL
THREE LAYERS.

The effect of the moisture on film morphology is also pronounced. Figure 18 shows the individual sputtered layers for one side of Q509 (no delay after air firing), as revealed by the electron microprobe technique. The individual layers are continuous and discrete. Figure 19 depicts the layers for Q518 (3-day delay after air firing). The titanium layer next to the BeO is not continuous. This represents the general phenomenon that the presence of moisture does interfere with the deposition and nucleation of uniform titanium. Figure 20 depicts the film layers for Q519, which did not experience air firing at all. Again the titanium has an island morphology and is not continuous. The ramifications of titanium are that without this active metal, bond strength is always lower than with it. When it is not continuous, its effect is reduced.

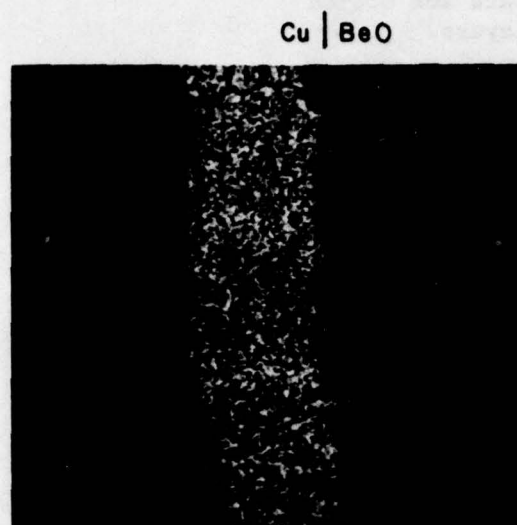
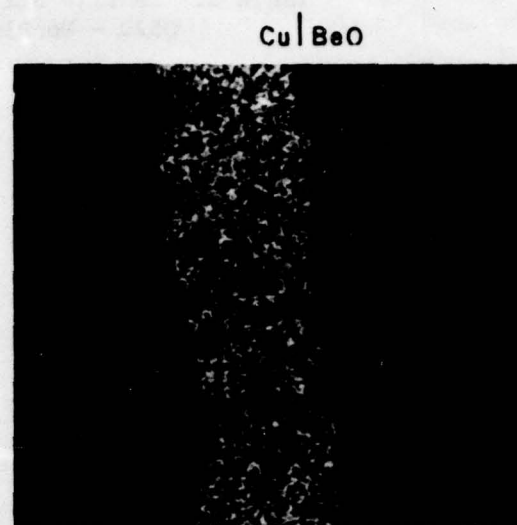
Figure 21. Copper Distribution for Q530, No Molybdenum (X3000).

A. AS SPUTTERED

B. 1000 °C FOR 24 HOURS

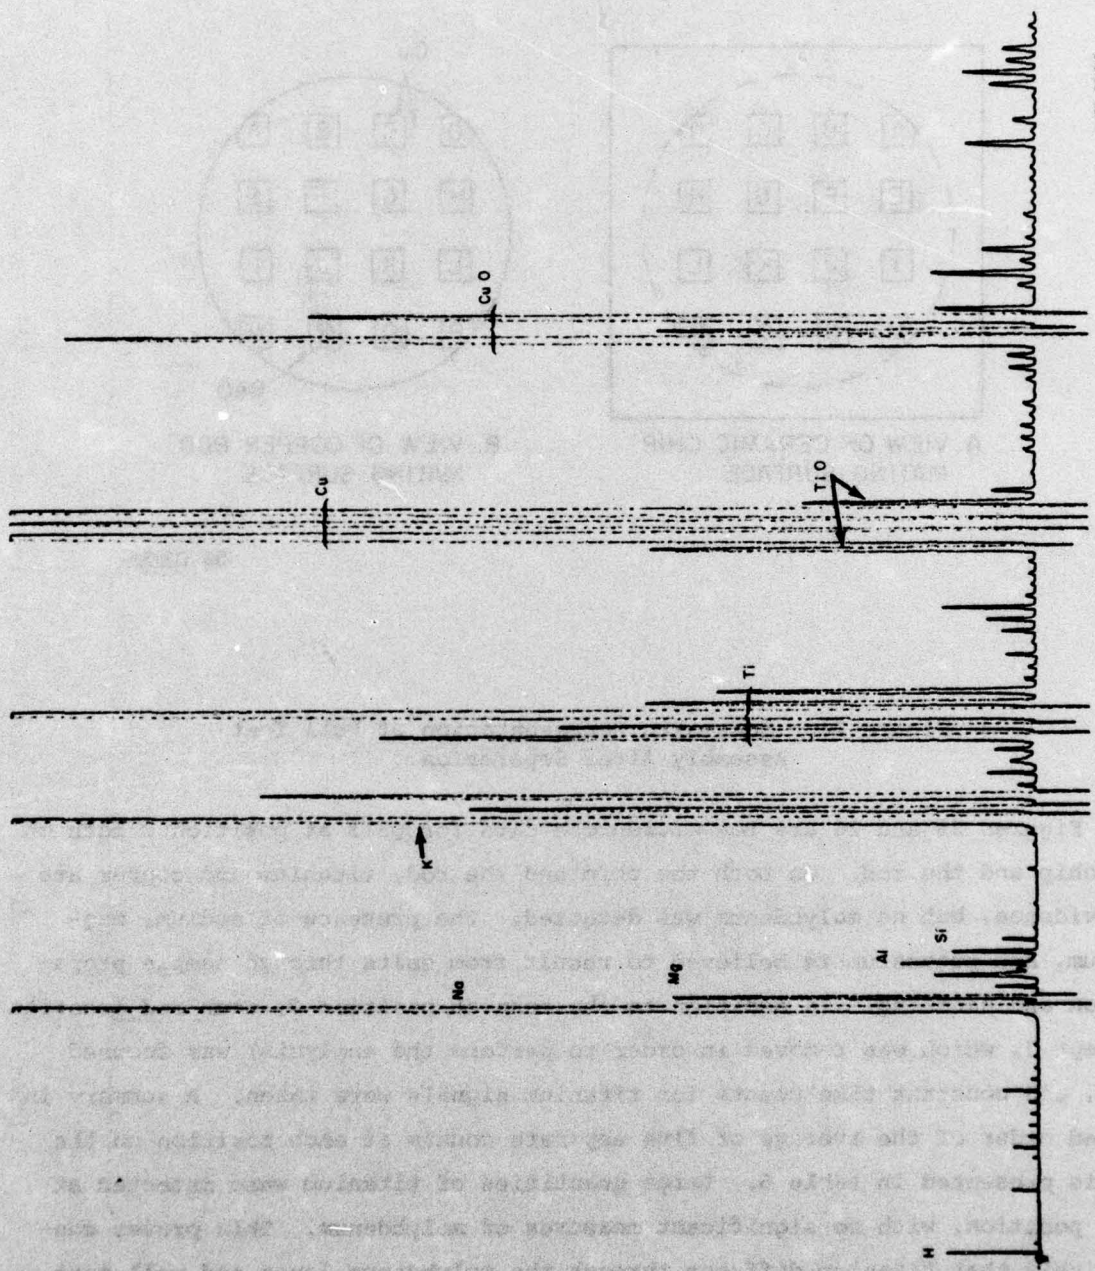
Figure 25. Ion Microprobe Data for Position C on Coupon Q513 (Chip).

Figures 25 and 26 are ion microprobe data for Q513 at position C both on the chip and the rod. On both the chip and the rod, titanium and copper are in evidence, but no molybdenum was detected. The presence of sodium, magnesium, and potassium is believed to result from salts through sample preparation and handling. In addition to the scan at position C, each rod location (except J, which was removed in order to perform the analysis) was focused onto, and constant time counts for titanium signals were taken. A summary in ranked order of the average of five separate counts at each position on the rod is presented in table 6. Large quantities of titanium were detected at each position, with no significant measures of molybdenum. This proves conclusively that titanium diffuses through the molybdenum layer and well into the copper sputtered layer. This also supports the fact that failure occurred within the copper and not at any boundary between the metallic layers.

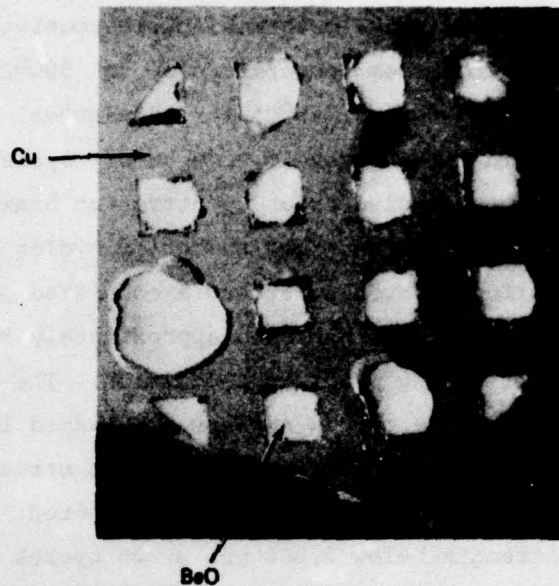
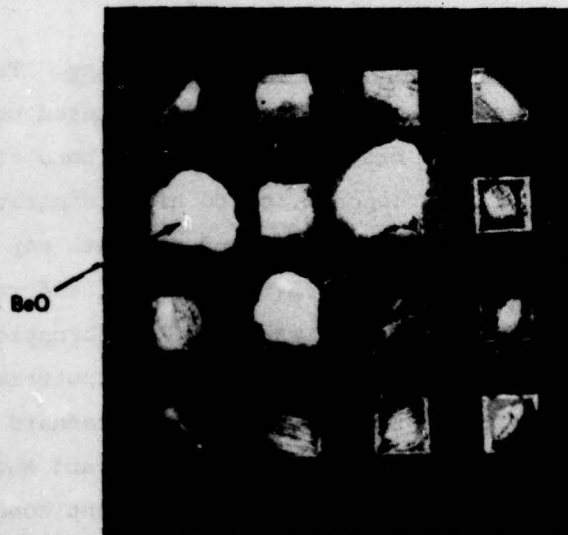
Figure 28. Failure Modes With and Without Thermal Cycling.

- a) DIRECT VIEW OF Q509 NO. 1
COUPON AFTER TENSILE
FAILURE TEST - NOTE CERAMIC
FRACTURE AT POINTS OF
CONTACT BY PULL TEST ROD.
TENSILE STRESS: 12,430 psi
X 10

- b) DIRECT VIEW OF COUPON Q513
NO. 11, AFTER TENSILE FAILURE.
SOME CERAMIC FRACTURE AND
SOME COPPER STILL AT POINTS
OF CONTACT. TENSILE STRESS:
2626 psi X 10

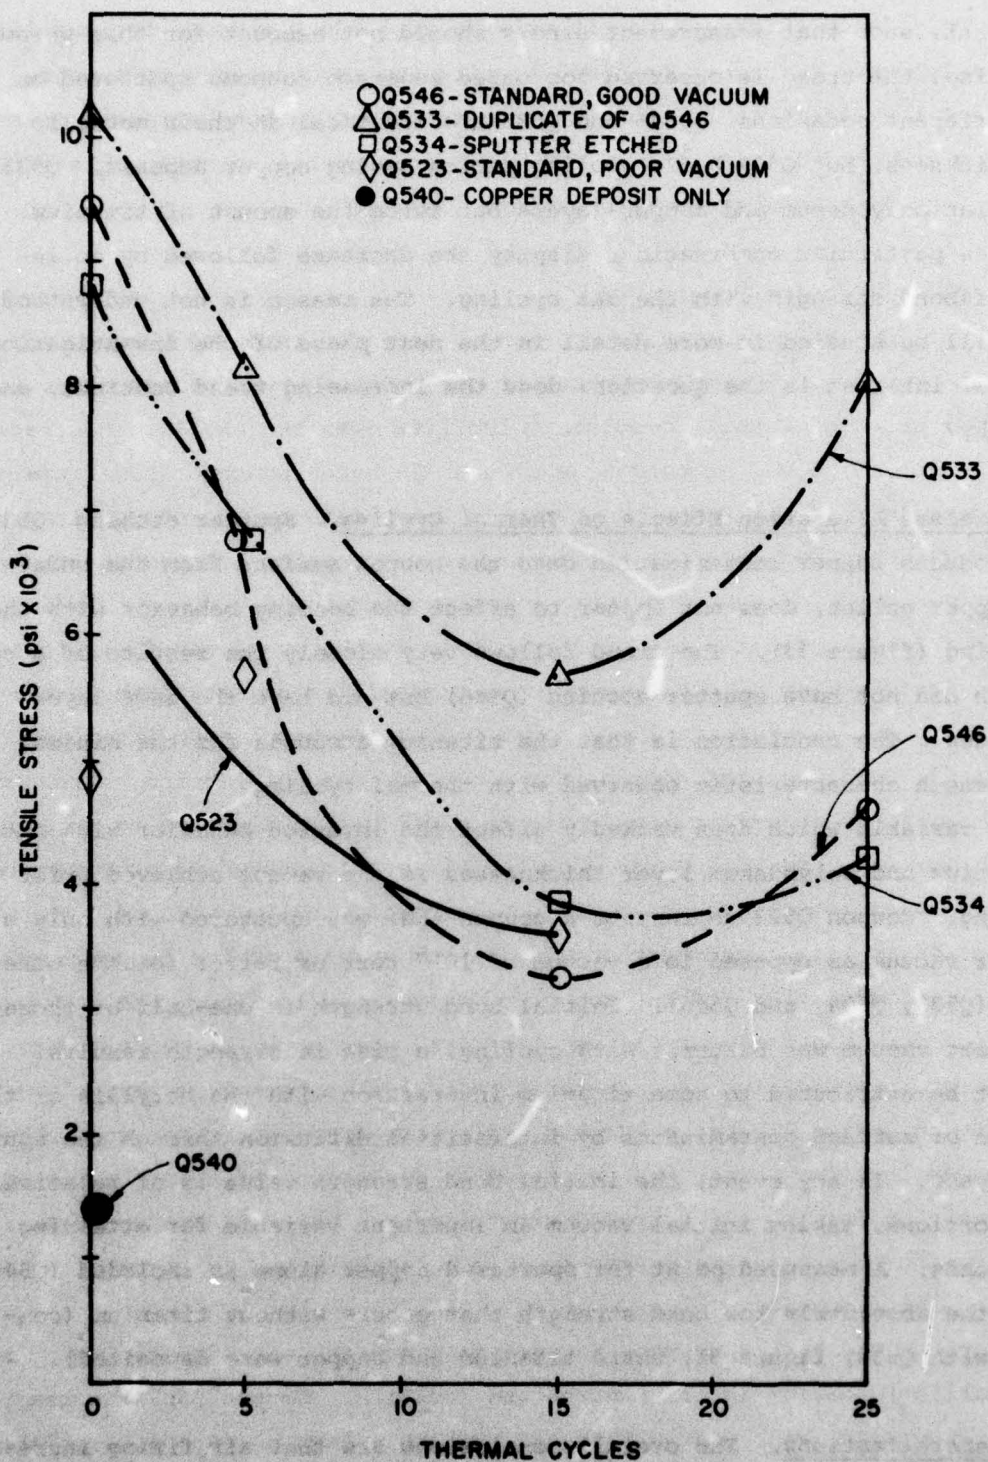
Figure 33. Thermal Cycling Effect on Bond Strength for Standard Sputtered Layer Thicknesses With Different Initial Conditions.

5.5.7 Generalizations. The overall conclusions are that air firing increases the initial bond strength attainable and that delay prior to sputtering markedly affects the decrease in strength with cycling, acting as an accelerating

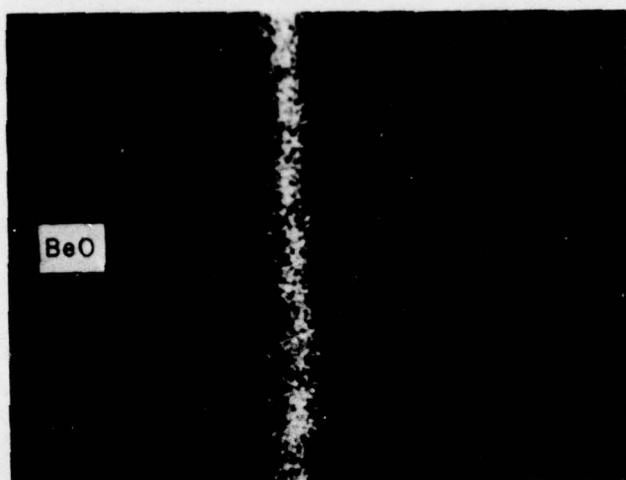
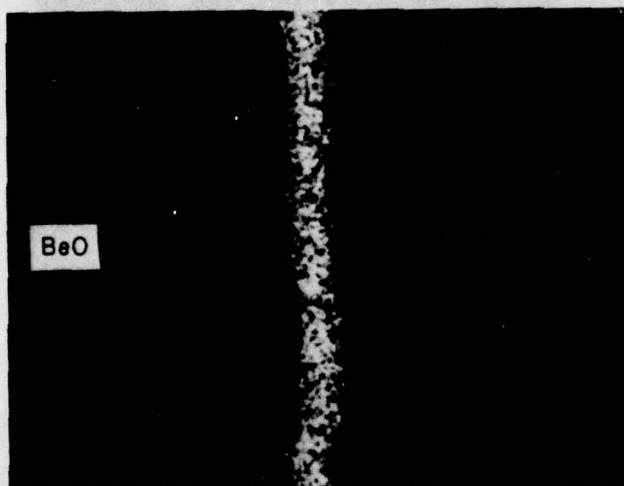
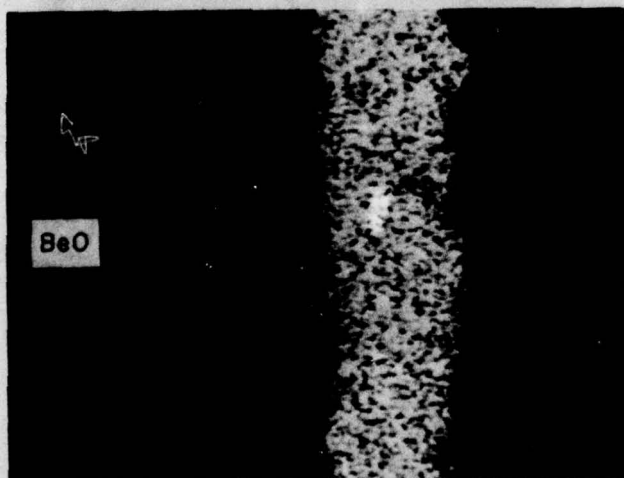
Figure 37. Film Morphology for Q537, As Sputtered,
Revealed by the Electron Microprobe.

A. TITANIUM LAYER X3000

B. MOLYBDENUM LAYER X3000

C. COPPER LAYER X3000

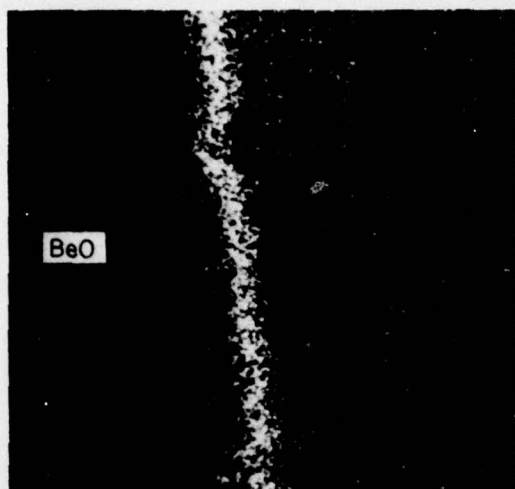
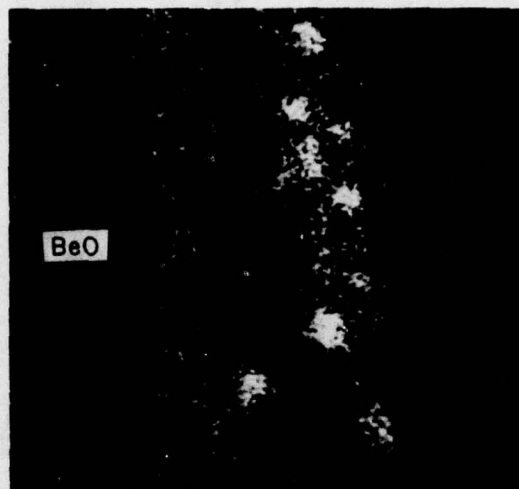
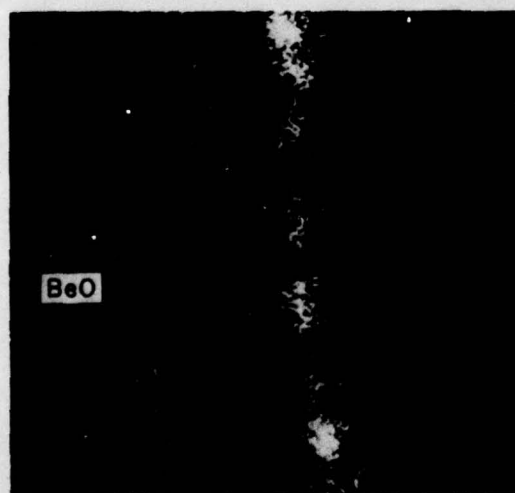
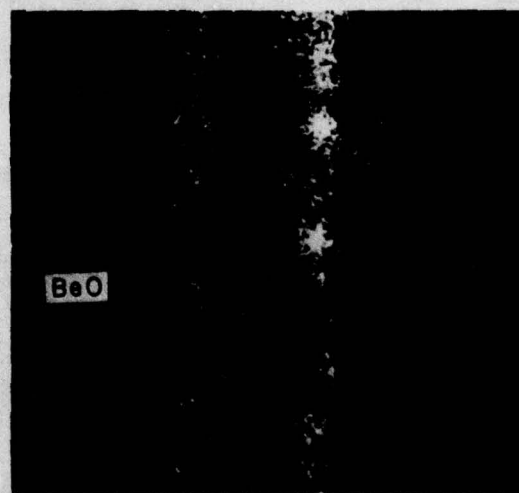
Figure 38. Titanium Spatial Relationships With Thermal Excursions, As Revealed by the Electron Microprobe.

A. 50 THERMAL CYCLES WITHOUT RODS

B. BRAZE TEMPERATURE WITH RODS ATTACHED AND NO CYCLES

C. 50 THERMAL CYCLES WITHOUT RODS AND BRAZE TEMPERATURE WITH RODS

D. BRAZE TEMPERATURE WITHOUT RODS AND NO CYCLES

The effect of the rods was expected to alter titanium diffusion because of the additional amount of strain energy introduced with the thermal expansion of the copper rods. At 1,000°C there appears to be sufficient thermal energy to induce titanium to diffuse into and through the molybdenum. Once it enters the copper, the migration occurs so fast that it moves forward along the copper grain boundaries, depleting any entering titanium as fast as it appears. The grain boundary migration proceeds into the copper until the exposed surface of the copper is reached. Once there, buildup occurs because this large grain boundary inhibits further movement, and the process of surface diffusion becomes predominant. Given sufficient concentration of titanium, intermetallic compounds form by nucleation and growth, because of the low energy required for this to occur at the very favorable nucleation sites of the free surface. An intermetallic compound is more stable and it acts to tie up any back diffusion of titanium because the titanium atoms are no longer free to dissolve out of the intermetallic state. The growth process continues until all of the titanium is converted into intermetallic compounds and equilibrium is achieved. This model explains the concentration of titanium at the free surface of the copper and its absence in the copper matrix. Occasionally, dense concentrations of titanium appear within the copper film as islands (figure 38B). Based on the model presented this can be rationalized as a site where compound nucleation occurred because of some imperfection in the copper film, and it behaves exactly like the free surface of the copper once this nucleus has grown to a stable size.

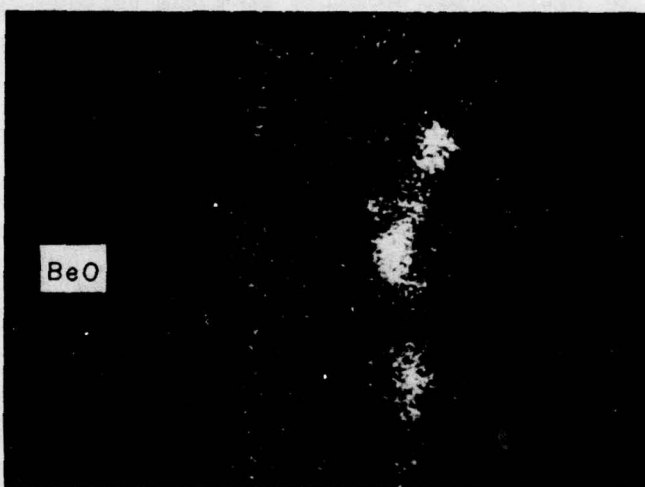
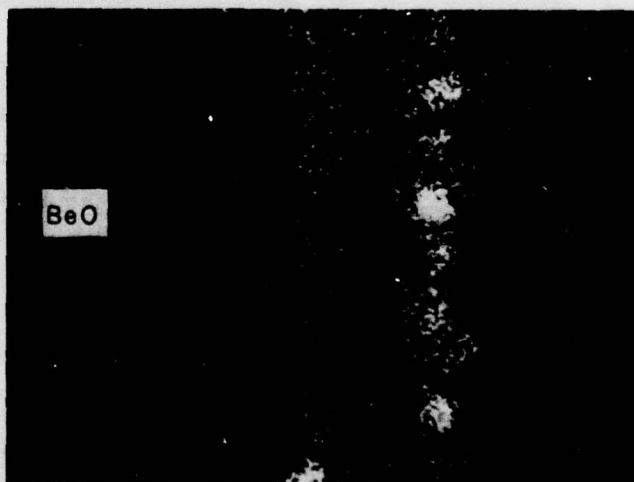
A. BRAZED AT 1015 °C WITH RODS PLUS
25 CYCLES

B. BRAZED AT 1015 °C WITHOUT RODS PLUS
25 CYCLES WITHOUT RODS
